Office of Structural Materials

Contract #: 04-0120F4Cty: SF/ALA Rte: 80 PM: 13.2/13.9File #: 1.28**WELDING INSPECTION REPORT****Resident Engineer:**Siegenthaler, Peter**Address:** 333 Burma Road**City:** Oakland, CA 94607**Report No:** WIR-025073**Date Inspected:** 06-Jul-2011**Project Name:** SAS Superstructure**OSM Arrival Time:** 700**Prime Contractor:** American Bridge/Fluor Enterprises, a JV**OSM Departure Time:** 1730**Contractor:** American Bridge/Fluor Enterprises, a JV**Location:** Job Site**CWI Name:** William Sherwood**CWI Present:** Yes No**Inspected CWI report:** Yes No N/A**Rod Oven in Use:** Yes No N/A**Electrode to specification:** Yes No N/A**Weld Procedures Followed:** Yes No N/A**Qualified Welders:** Yes No N/A**Verified Joint Fit-up:** Yes No N/A**Approved Drawings:** Yes No N/A**Approved WPS:** Yes No N/A**Delayed / Cancelled:** Yes No N/A**Bridge No:** 34-0006**Component:** SAS Tower**Summary of Items Observed:**

## WELDING INSPECTION REPORT

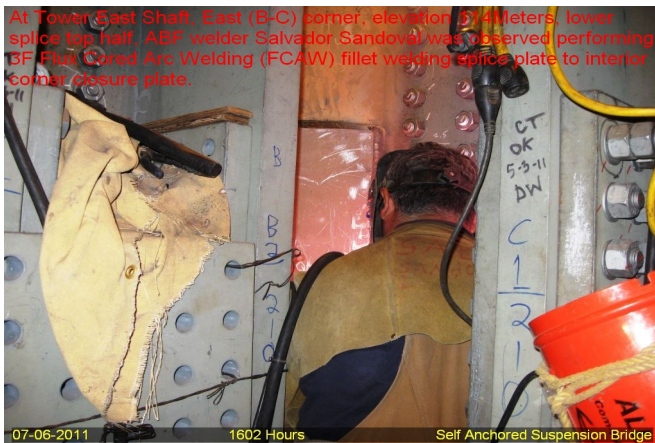
At Tower East Shaft Splice #3 @Elevation 114 meters;

At East (B-C) corner, lower splice plate; This QA Inspector randomly observed ABF welding personnel Salvador Sandoval continuing to perform production welding on the top half of the lower splice plate using the self shielded Flux Cored Arc Welding (FCAW) process with 1.8mm diameter E71T-8 wire electrode implementing Caltrans approved (WPS) ABF-WPS-D15-F2200-3. The welder was noted 3F (vertical) fillet welding the splice plate to interior corner closure plate of the tower shaft. This QA Inspector observed ABF personnel using propylene gas torch to preheat the plates to be welded prior to welding. This QA Inspector observed QC Inspector Steve Jensen using a Fluke infra red temperature gauge to verify the preheat temperature of more than 300°F. The welding appeared to comply with Welding Procedure Specification (WPS) ABF-WPS-D15-F2200-3. At the end of the shift, 3F fillet welding was still continuing and should remain tomorrow. ABF personnel were noted covering the weld with heater blanket in preparation for the three hours holding of preheat temperature of more than 300°F as required. ABF personnel were using Miller Proheat 35 Induction Heating System to hold the preheat that was programmed to shut off after three hours.

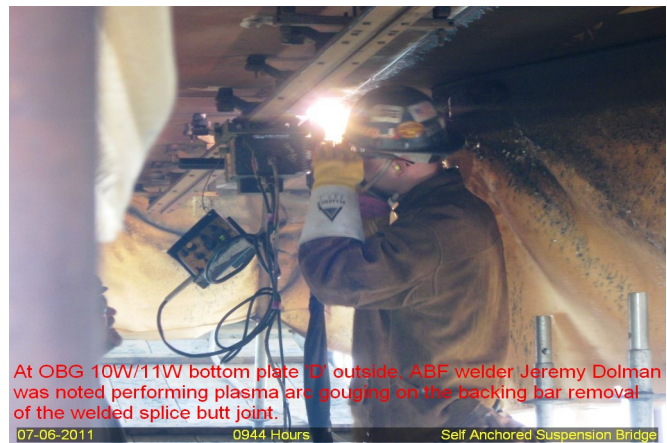
At OBG 10W/11W bottom plate 'D' outside, QA randomly observed ABF personnel Jeremy Dolman perform plasma arc gouging on the backing bar removal of the welded splice butt joint. The personnel was using an Esab plasma arc gouging machine that has the nozzle holder attached to a Bug-o track. Gouging of the backing bar was not completed today and should continue tomorrow.
